Department of Water Resources

BULLETIN No. 116-5

THE ALASKAN EARTHQUAKE

OCTOBER 1965

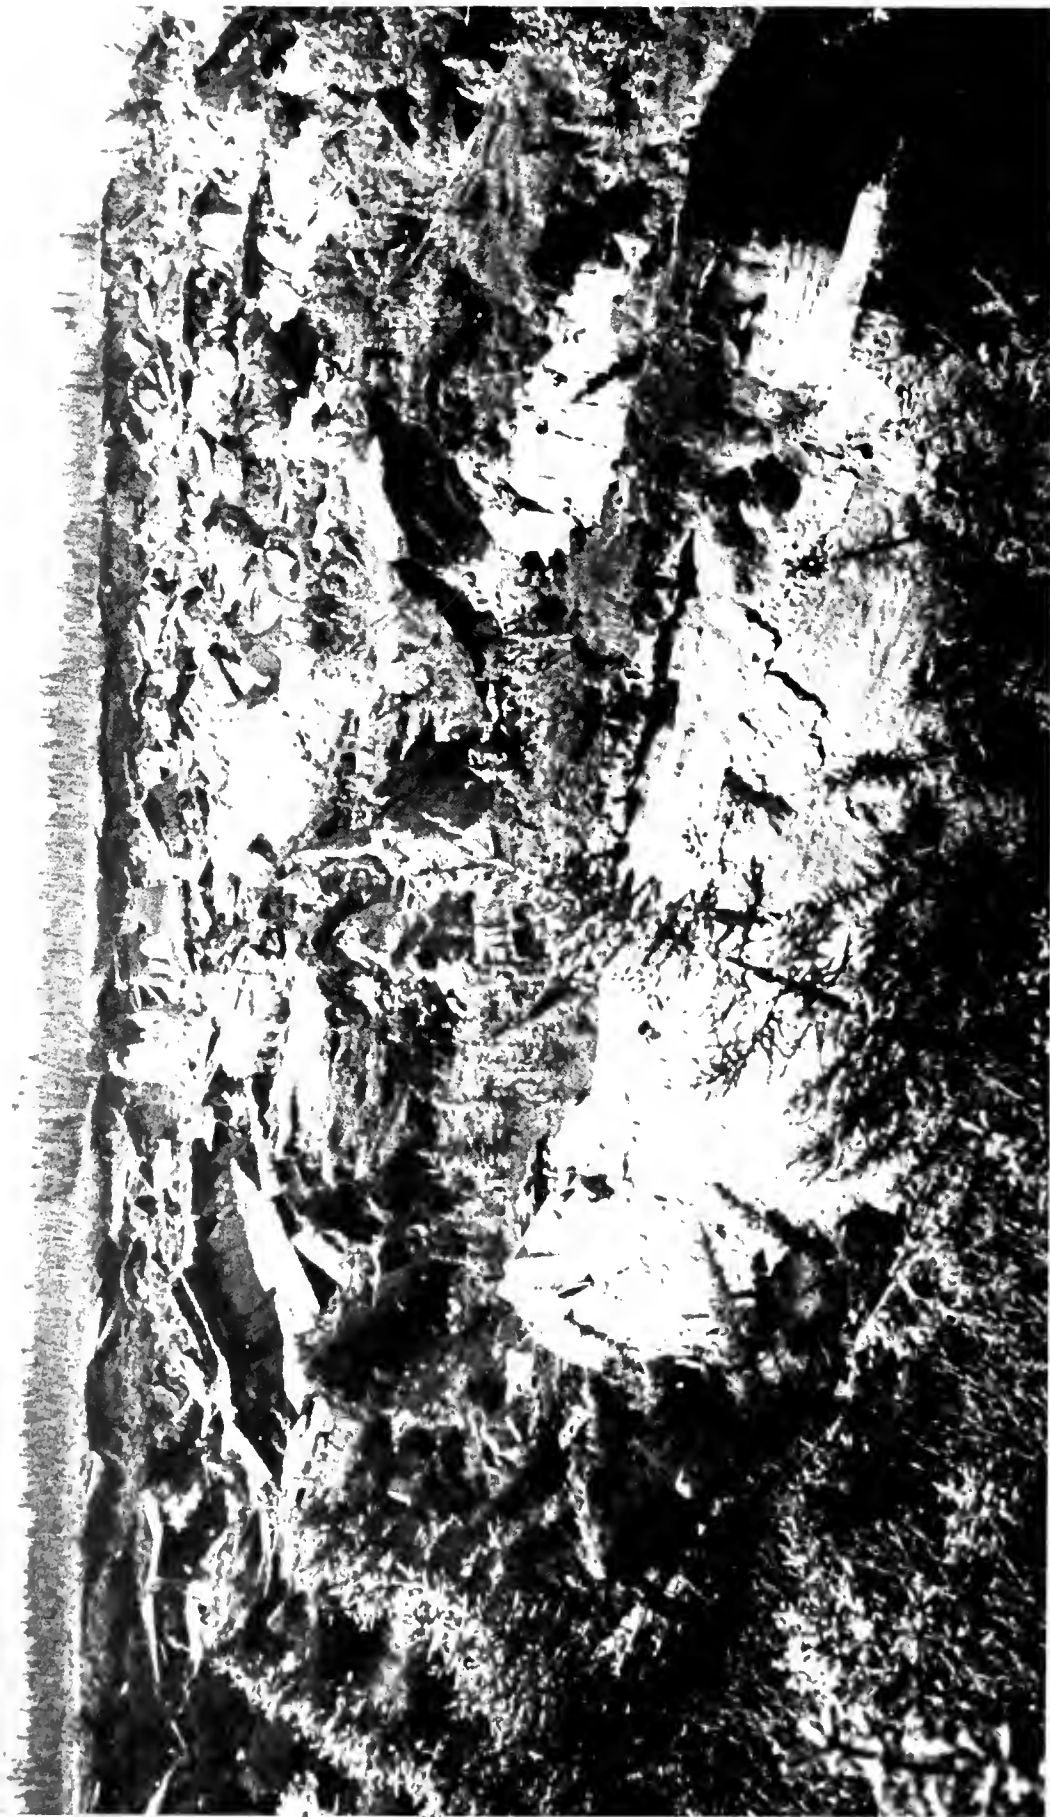
The Turnagain landslide, Anchorage, Alaska

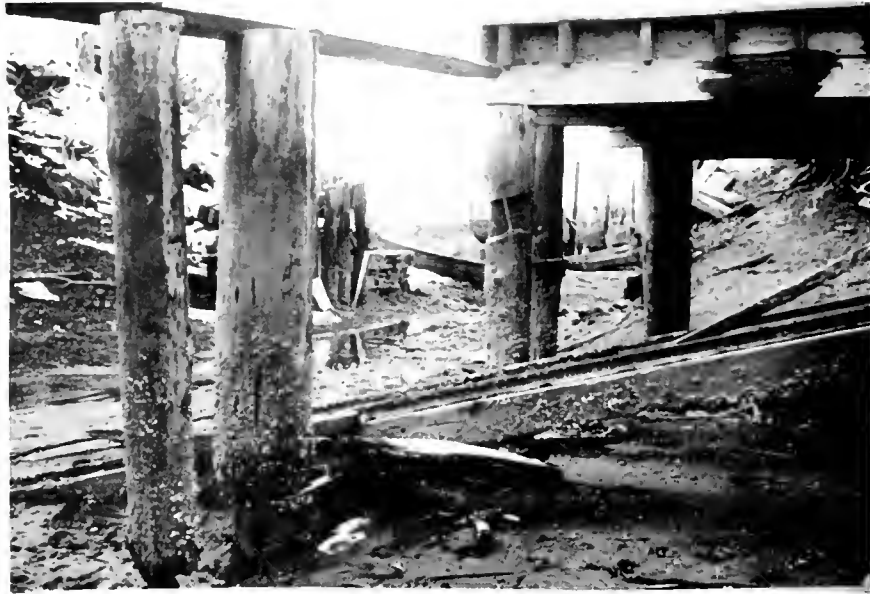
Illustration 1. Inlet to small boat harbor at Cordova. Picture was taken at high tide and shows result of tectonic uplift on coastal communities.

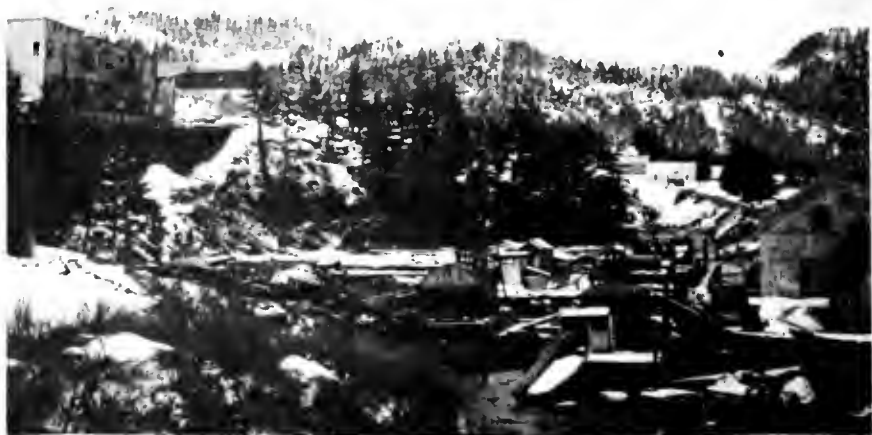
Illustration 2. Inner harbor at Cordova during high tide.

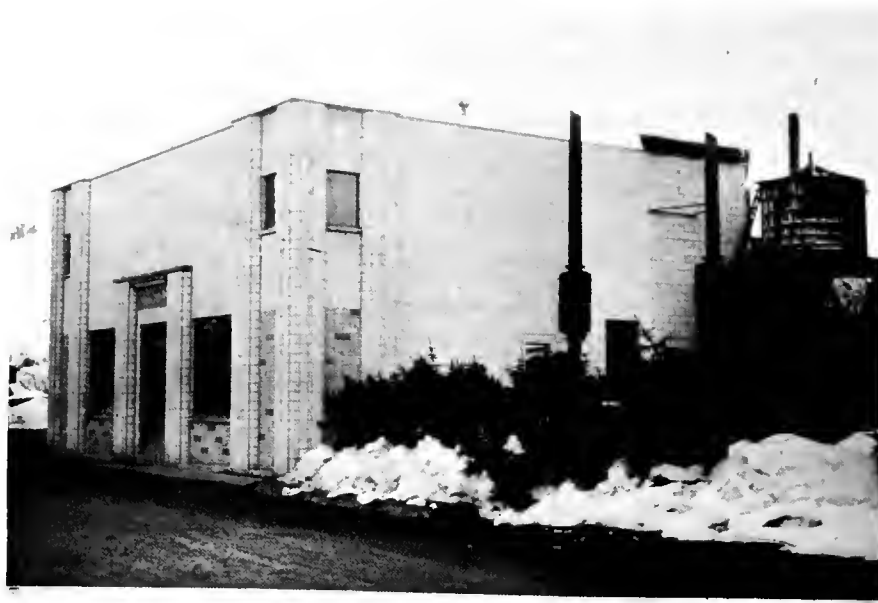
Illustration 3. Meals building in Valdez
(power plant). No damage.

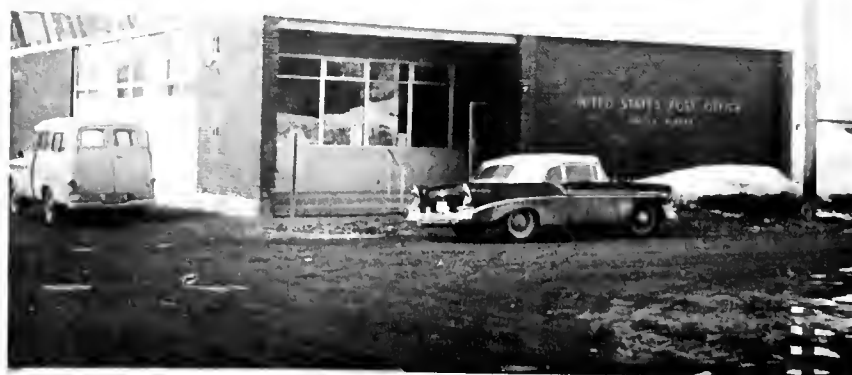
Illustration 4. Post Office in Valdez.
No damage.

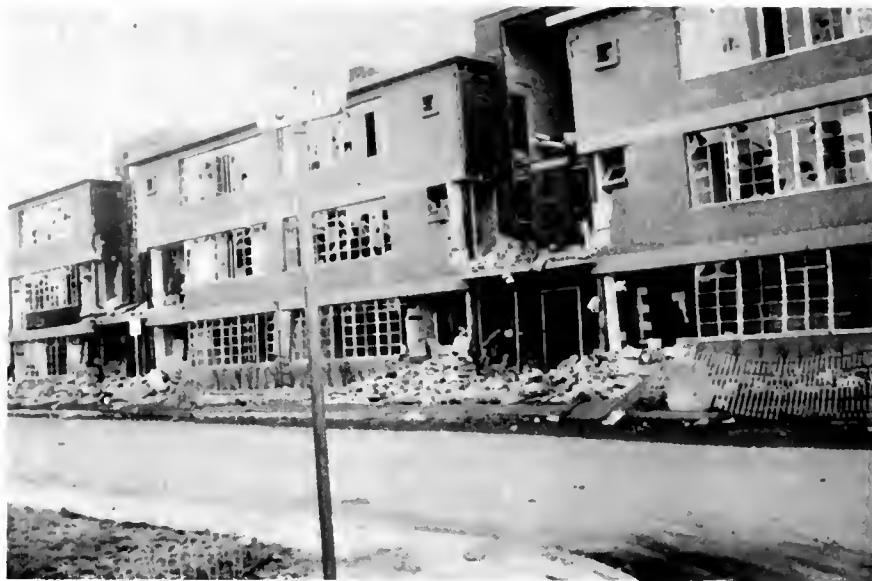
Hollow concrete block was a common building material used for commercial and industrial structures as well as apartment houses. Much earthquake damage occurred to structures using this type of construction material, because (1) as shown in Illustration 5, there was insufficient reinforcement, or no reinforcement at all to resist seismic forces, and (2) there was insufficient overlap of reinforcement steel to transfer stresses from one bar to another.

Illustration 5. An apartment building in Anchorage constructed mainly of hollow blocks. The damaged blocks showed apparent lack of reinforcement to resist lateral deflections.

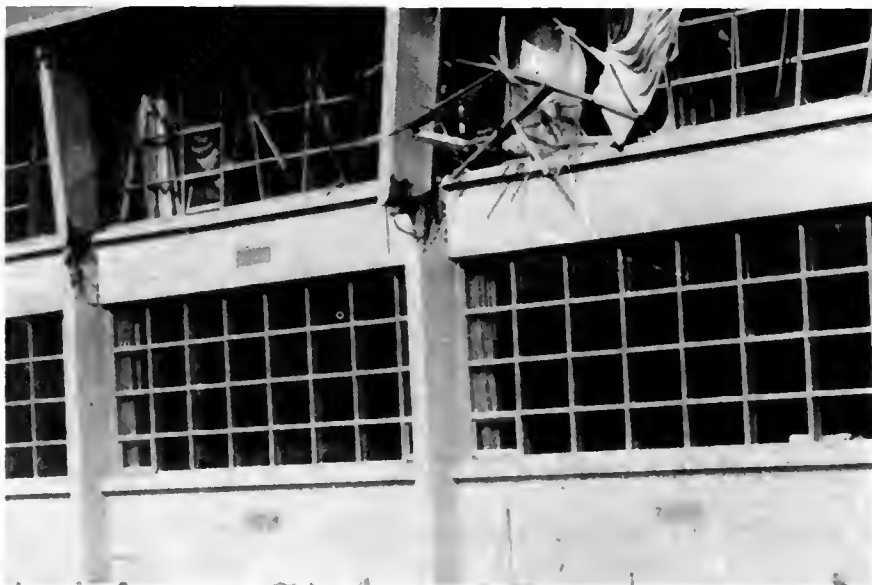
Illustration 6. Structural failures due to insufficient reinforcement steel and concrete area.

In other instances, lack of reinforcement and concrete area in column connections to floorings or roofs did not permit the columns to transfer the moments or shear structurally, resulting in fractured columns. This type of failure occurred at the West Anchorage High School. Illustration 6 shows failures resulting from insufficient reinforcement steel and concrete to resist the lateral shear forces.

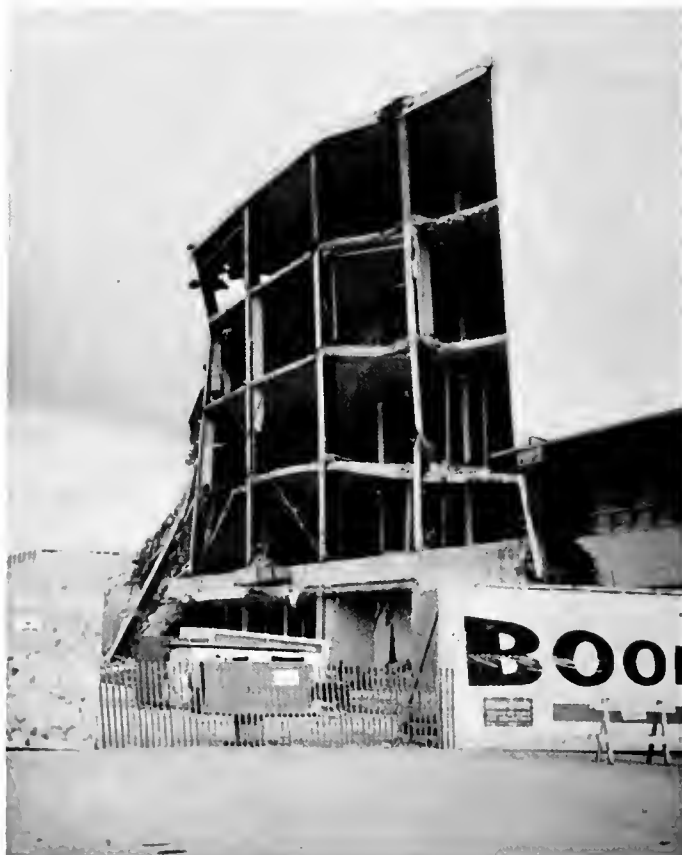
In the J. C. Penney Building, precast panels were connected to the steel frame as an exterior wall. During the earthquake, connections between these panels and the steel frame failed when they could no longer restrain the deflections of the frame. This failure was due to the difference in relative stiffness of the two elements and the error in designing the structure to act as a homogenous system to resist lateral forces dynamically. See Illustration 7.

Illustration 7. The J. C. Penney building
in Anchorage.

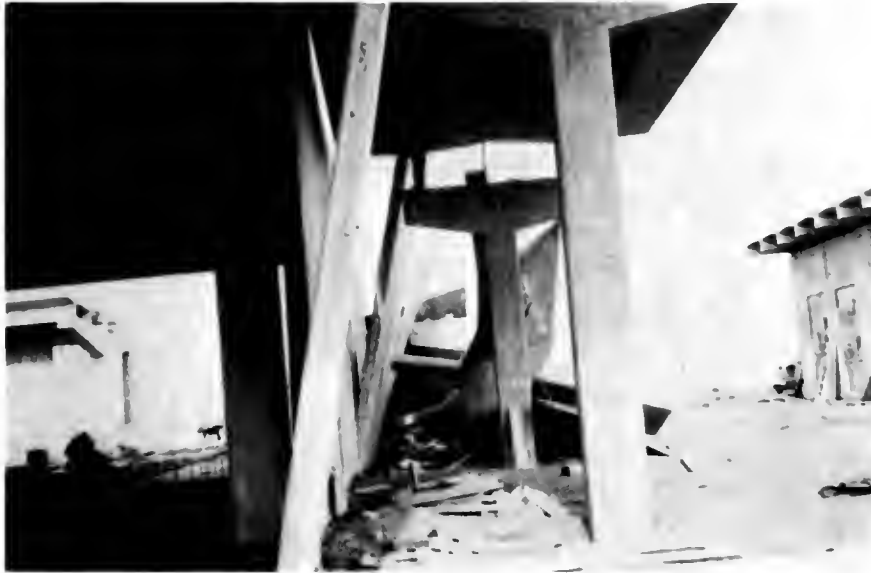
Another type of design failure resulted from inadequate connections between precast elements. A good example was the Alaska Sales and Service Building which was constructed of precast panel walls, and precast "T" beam roof resting on precast reinforced concrete bents. Interconnections between the precast elements were made by means of welded metal connections. After the earthquake, investigations showed that the connections failed causing the walls to collapse or tilt out of plumb. See Illustrations 8 and 9.

Illustration 8. Connection failure of precast members resulting in separation of wall from roof.

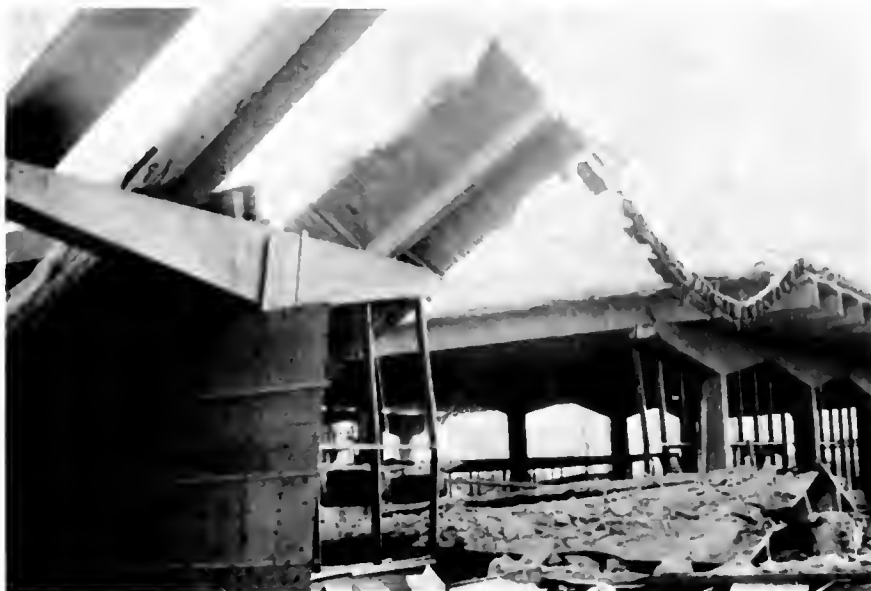
Illustration 9. The Alaska Sales and Service Building in Anchorage is a good example of damage resulting from defective connections in precast concrete construction.

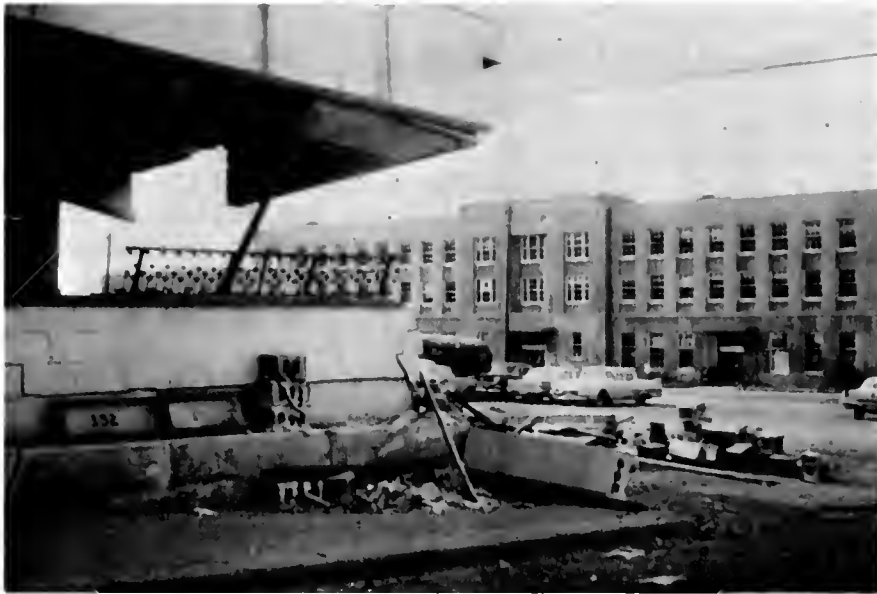
It is obvious that no matter how well a structure is designed by the engineer, his efforts will be wasted if the structure is not built according to his plans and specifications. Hollow concrete block construction, which was a common material used in structures in Anchorage, suffered greatly from failures that were attributed to faulty construction.

Illustration 10. Hollow concrete blocks showing lack of grout in cells.

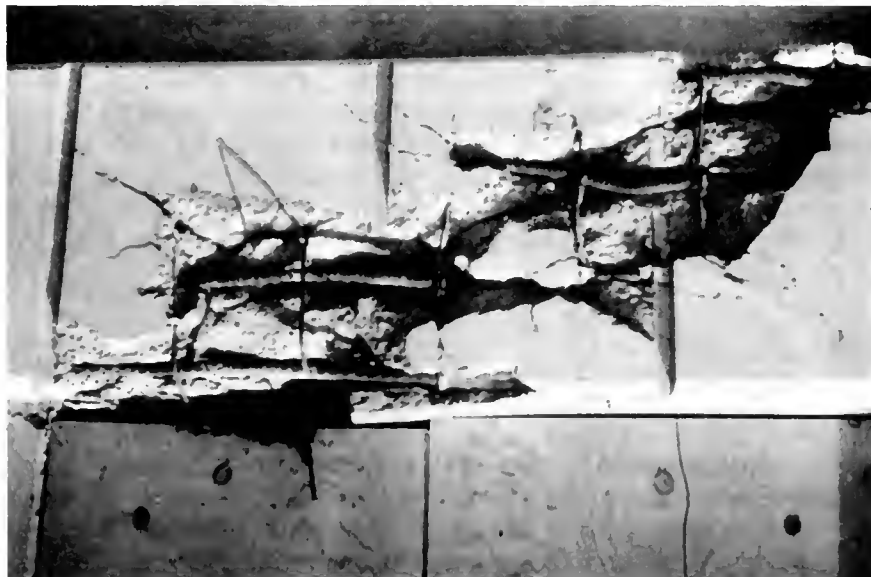
Improper concrete mix in some reinforced concrete structures resulted in the concrete possessing inadequate compressive strength. Failure occurred when the concrete could no longer withstand the loads resulting from the vibration and causing the concrete to bulge out or "mush out" in a manner similar to column failures resulting from insufficient ties. The plasticity of the concrete caused the tremendous load to be transferred to the reinforcement steel, resulting in a bending failure of reinforcement. An example (showing column buckling of reinforcement steel) is shown in Illustration 11.

Illustration 11. Compression failure due to inability of reinforcement to sustain transferred load resulting from plastic flow of concrete.

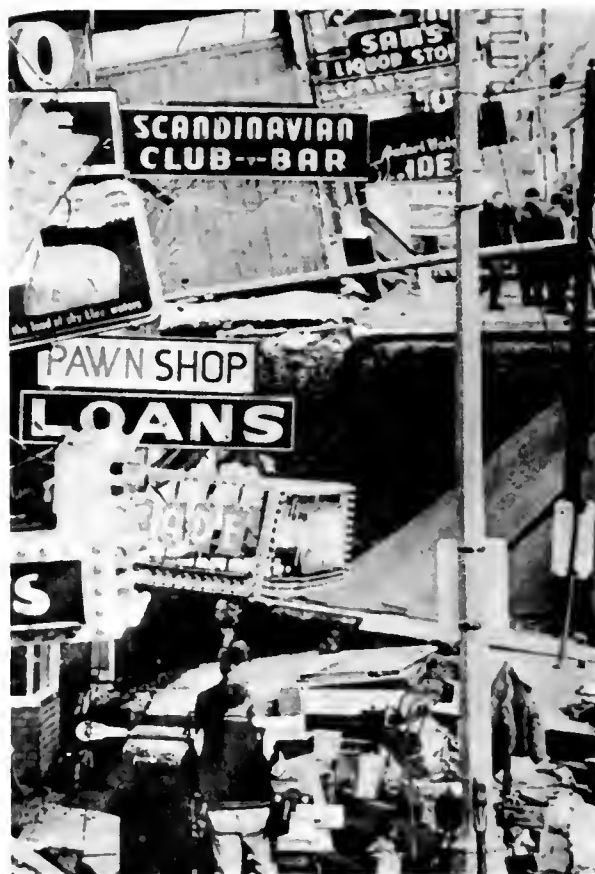
Illustration 12. Fourth Avenue landslide in Anchorage.

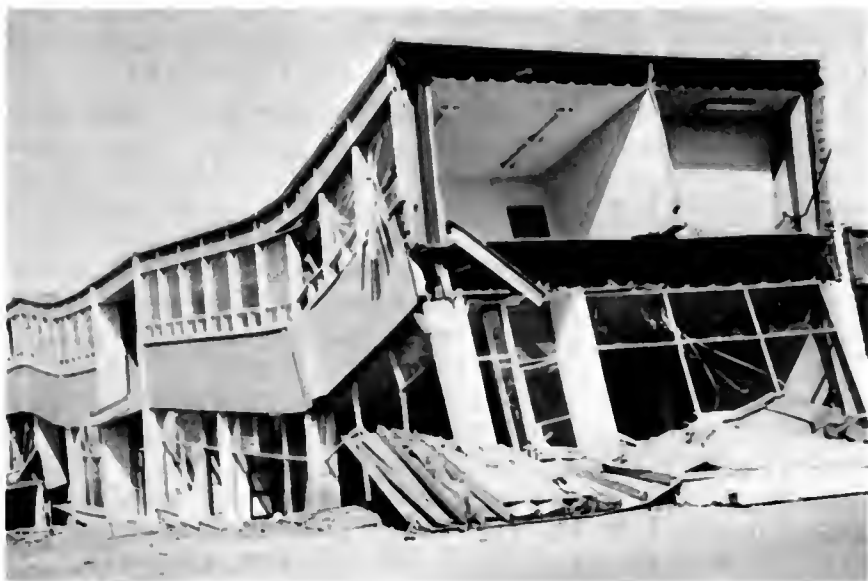
Illustration 13. Building damaged by movement of foundation.

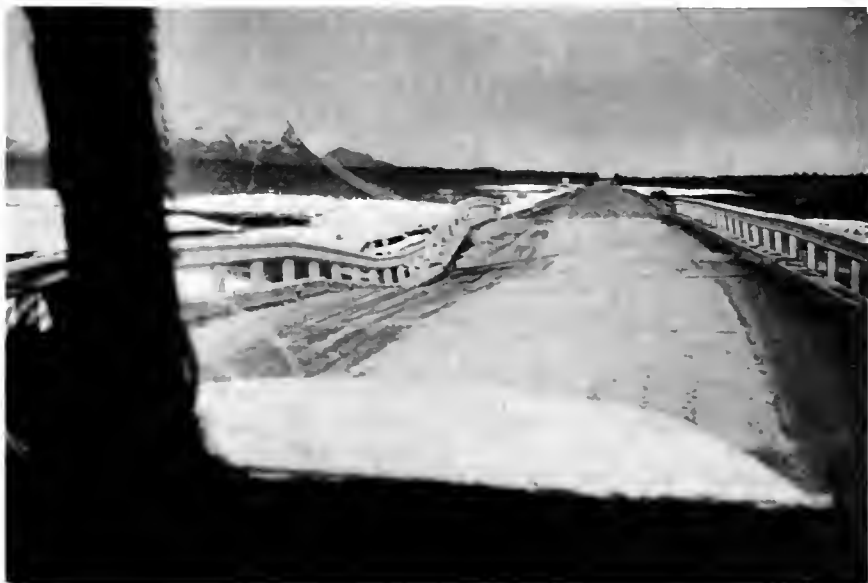
Illustration 14. Sag in highway fill near Cordova.

Damage from settlement of poorly consolidated glacial outwash and other types of alluvial materials were noted in a number of areas. The Copper River highway which traverses approximately 14 miles of bay mud and muskeg near the town of Cordova suffered much damage from settlement and lurching of highway fills on these poor foundation materials. Structures of the Eklutna Project were damaged by settlement of alluvial materials. Settlement of soil combined with tectonic subsidence lowered the seaport town of Homer Spit, causing inundation by the sea, and caused about 5 miles of the Alaskan Railroad to be inundated in the vicinity of Turnagain Arm.
